ENGINEERING REPORT

**RED LIGHT RUNNING TRAFFIC MONITORING
SYSTEM**

**State Route 99/ Pacific Highway at S 216th Street City of
Des Moines, WA**

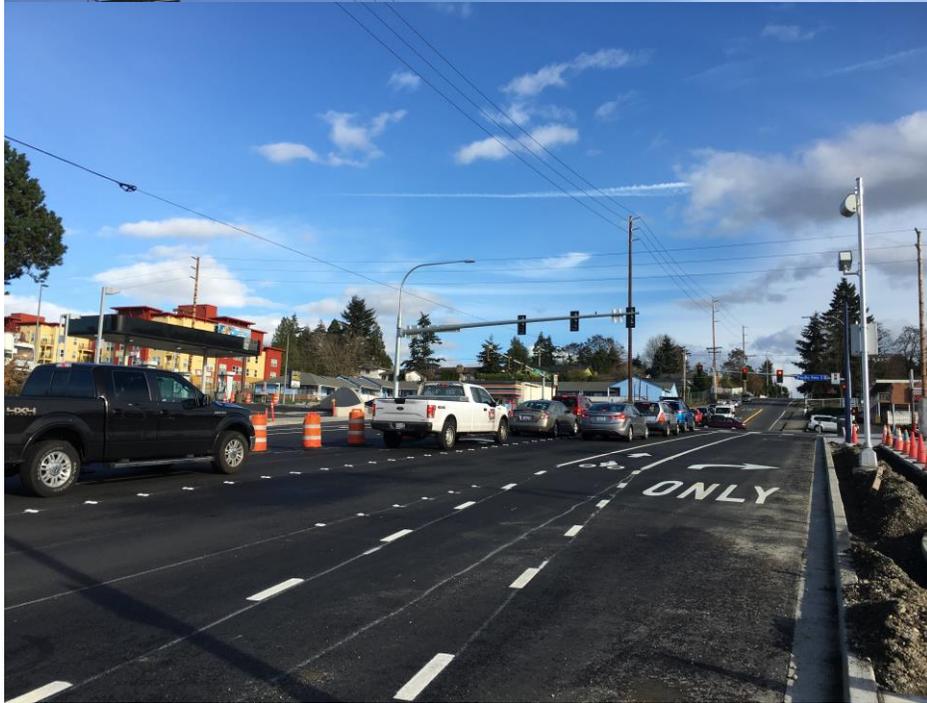
Figure 2: Eastbound approach, looking east

There are no visual obstructions to the signal heads on the southbound direction of SR 99 and the signal heads on the eastbound direction of S 216th St. the approach grades are relatively flat on both approaches. The visibility to the signal meets the required MUTCD standards (Table 4D.12/ Section 4D.12)

The approach grade is measured to be an increasing slope of 6.3%, reaction time of 1.0 second, deceleration rate of 10ft/s², vehicle approaching speeds is 40 mph (5 mph over the speed limit). The calculated Yellow change interval equals 3.7s.
